# Spontaneous Breakage of Thermally Toughened Glass

by Ben Wallace, Glass and Glazing Federation

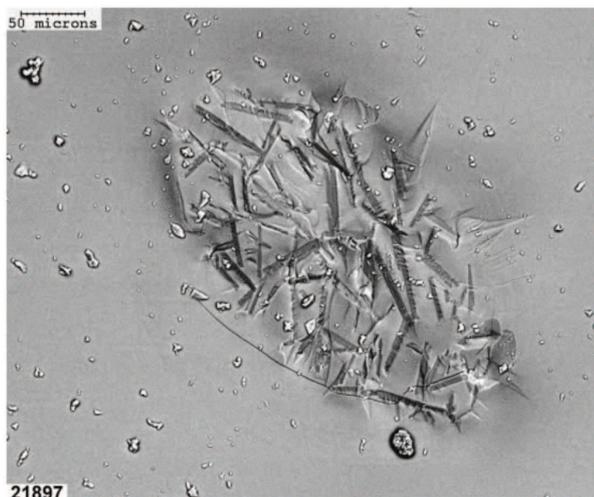
Above, example of un-melted frit

If these are sufficiently large and in the tensile stress zone (towards the centre of the glass thickness), they can disrupt the stresses built into toughened glass to an extent that the glass fractures from around the inclusion. Often this will occur during manufacture, but it can also occur sometime after manufacture, usually fairly quickly, but it may be a matter of months. Toughened glass containing a non-critical inclusion which survives longer than a few months is very unlikely to fracture from the inclusion in service.

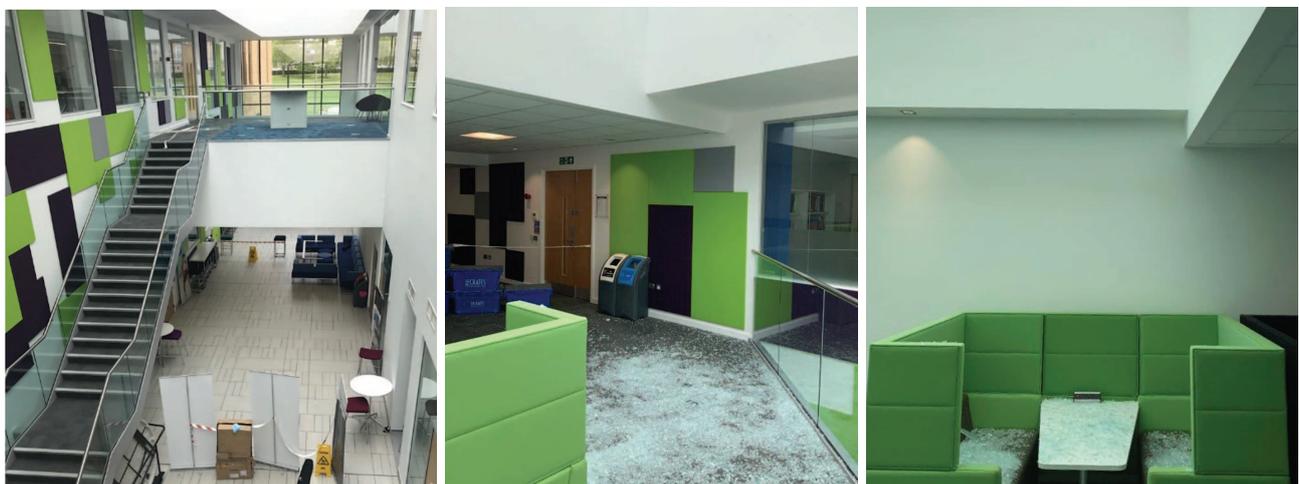
The above three images show an example of the incorrect glazing in the overhead position that has suffered Spontaneous Fractures due to Critical Inclusions. The images effectively demonstrate the safety implications of these fractures.
